## Appendix E Town of Claremont

### APPENDIX E.1 HISTORIC AERIAL IMAGE COMPARISONS FOR TOC

### APPENDIX E.3 STRUCTURE CONDITION AND FUNCTION COMPARISON TOC

## APPENDIX E.4 DAMARA WA (2015) STRUCTURE AND DRAIN ASSESSMENTS FOR TOC

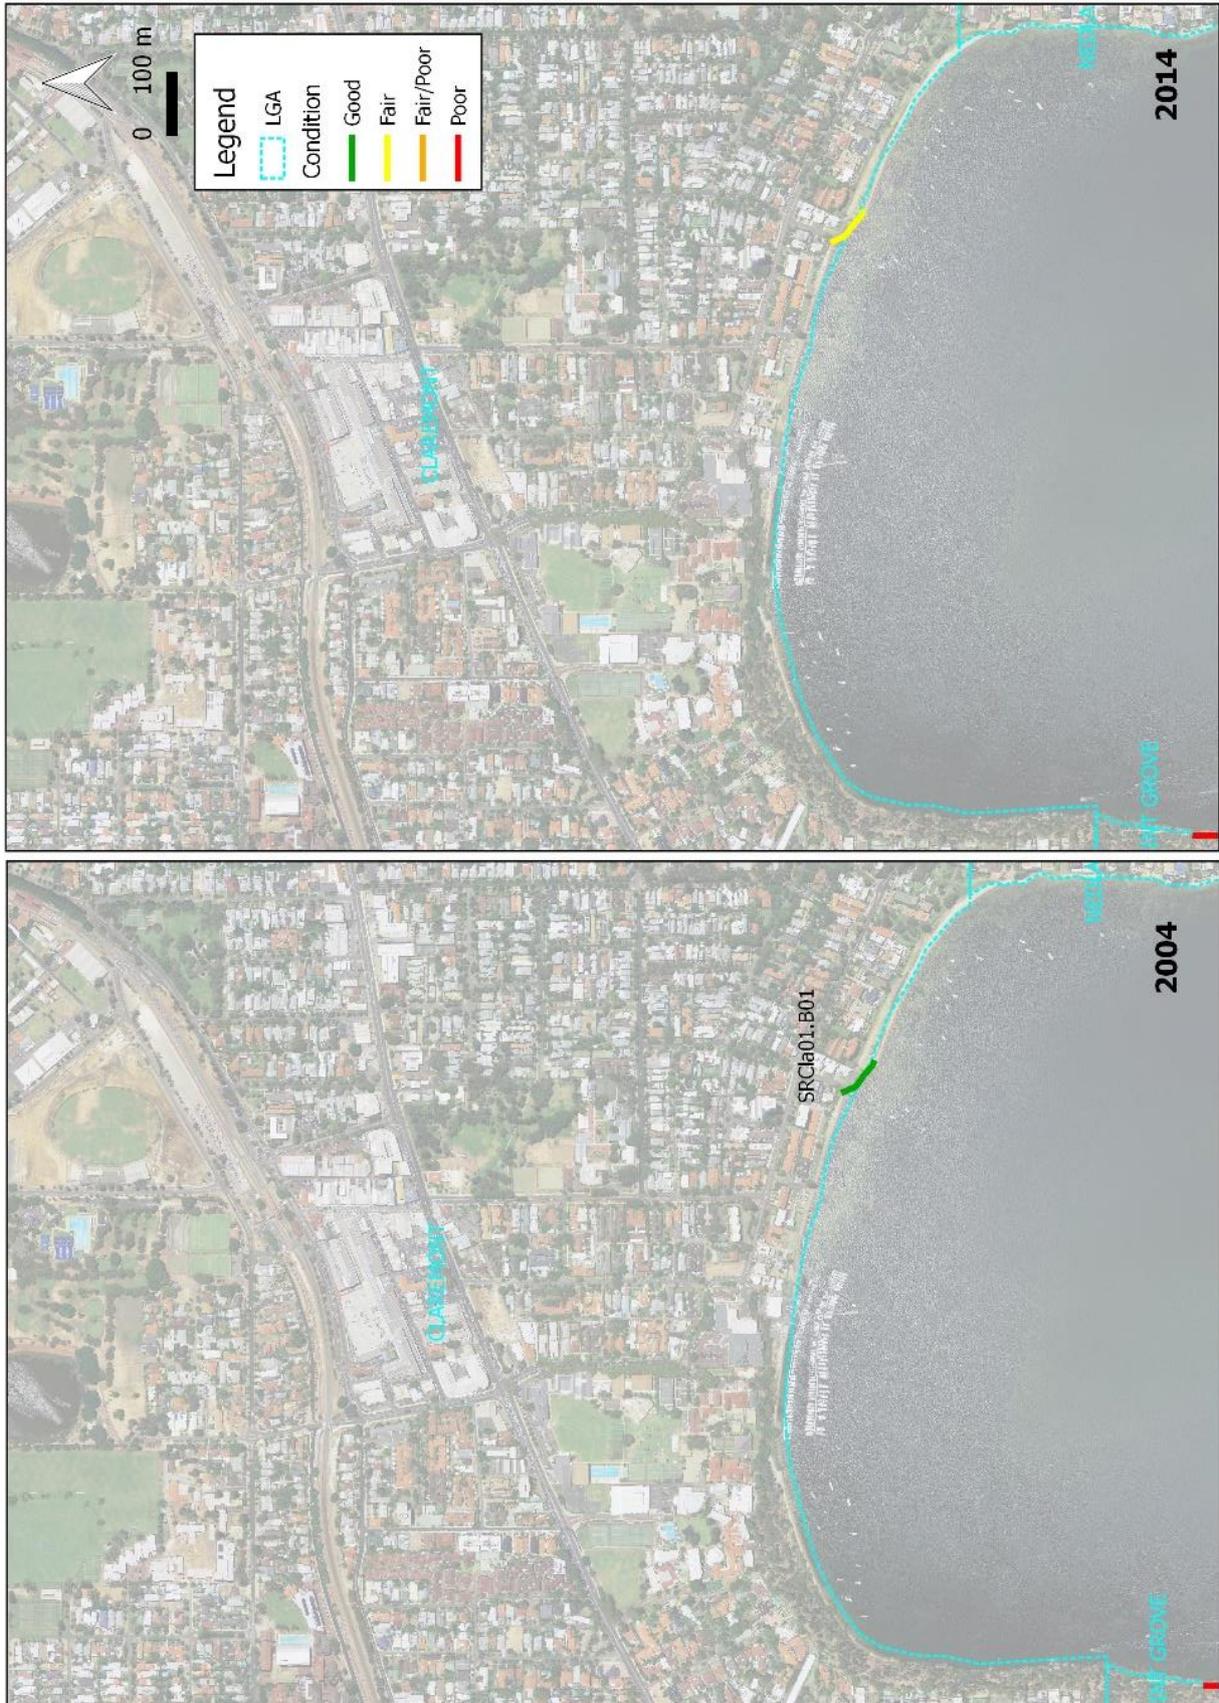
Figure 12-70: Town of Claremont Structure Condition 2004 and 2014

The comparison of structure condition is included in Figure 12-70 and the comparison of foreshore retention function in Figure 12-71, with the 2004 results in the left panel and the 2014 in the right panel.

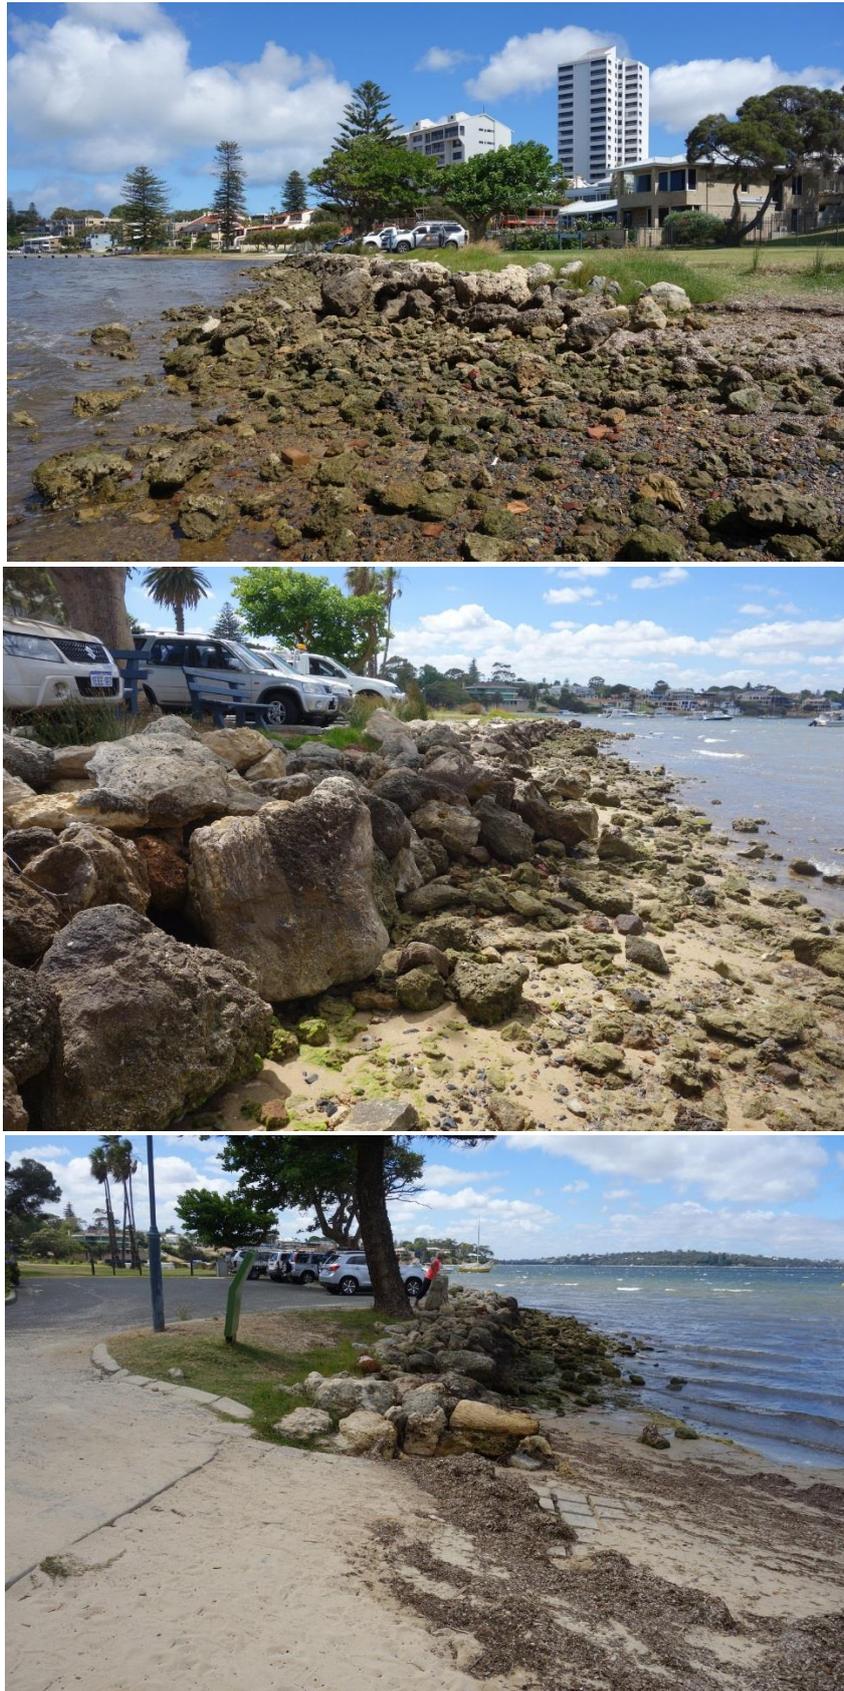
**Figure 12-74: Photos SRCla01 Mrs Herberts Park.B01 8 December 2014**

- SRClA01.B01 - Revetment has been extended further upstream (east) since 2004.

- Town of Claremont: SRClA01.B01

ID	L. (m)	H (m)	Cond.	Cons.	Rank	Condition comment	Maintenance comment	Rater comments
SRCla01 Mrs Herberts Park: B01 (Rock Revetment/ Rock Rip Rap )	72	0.86	3	3	13	Limestone rock with some building rubble; Revetment immediately abuts car park (with small section of woodchips, sedge and kerbing between crest and carpark) which extends locally into the river compared to adjacent banks. Revetment has been extended upstream to retain grass area as a tie-in with flanking erosion (scarp in grass) and wrack accumulation. At upstream end some extra rock acts as a small groyne. At the downstream end there are local drains, a boat ramp and then private property. In the revetment there is armour unit breakage, toe flattening, loss of crest elevation, exposure (and loss) of core, loss of armour contact, slope steepening, drifters, no evidence of filter cloth, poor drainage management to landward, some voids and undersize rock (particularly at crest). There are a couple of sections that are condition 4. A lot of past patching is evidence, particularly in some areas with undersize rock. Erosion over and through the structure. Some areas of partial collapse. No obvious gradation in rock sizes to the core. Some steep face areas. Localised areas of runoff over the carpark from water accumulated in the carpark (385069 6460057) running off the steep hill. Car park itself has broken kerbing, movement of bitumen and areas with unmanaged runoff. At toe of revetment there are drifters and old core, with groundwater seepage. Evidence of overtopping.	Immediate maintenance and Remove/rebuild; Immediate maintenance includes avoiding using undersize rock in future, replace drifters into revetment, create a more gradual sloped toe and raise level of the revetment in collapsed areas. Maintain two PVC drains to ensure siltation is minimal and consider adding another drain for local runoff at 385069 6460057 at end of car park (note this will be a point of focal failure under wave conditions and require frequent [6-monthly maximum] maintenance). Renourishment required at upstream extent to manage updrift erosion. Overall the main recommendation is to Rebuild/remove. Shift the front area of the carpark landward and extend further upstream to ensure the same number of bays, but without extending as far riverward. The norfolk pine tree would be maintained, but the pepper tree would be lost, which would require community consultation. If carpark moved the revetment should be reconstructed as a layered revetment with reduced slope, filter cloth, core and good interlocking.	Purpose is shore realignment (it is effectively realigning the shore for adjacent foreshores and holding the line for the carpark), structure protection (car park, boat launching ramp). Historic purpose was Claremont baths; Consequence (3) because of asset value of carpark, reconstruction of revetment and complaints by public

Short-term (risk management) for 0-5 years		
Goal	Capital works and costs	Maintenance works & costs
Improve resilience for interannual variations in MSL and winds.	<p><b>Modify car park revetment</b> for gradual tie-in to the east, increasing the curve to landwards and a more smooth transition. <i>Cost: \$10-15k (price increase may occur if pre-1931 reclaimed area requires excavation). Reuse existing rock.</i></p> <p><b>Create small drain</b> or drainage chute (grouted rock channel with low point to channel flow) at the low point in the car park. <i>Cost: \$2-3k</i></p>	<p>Manually breach the <b>sand bar at the Alex Prior drain</b> (≈monthly towards neap tides). Sediment can infill the scour hole under the drain (reduce ponding) or go on adjacent beach. <i>Cost: In-kind labour</i></p> <p>Maintain <b>sedge</b>. <i>Cost: \$2k pa + in-kind labour</i></p> <p><b>Minor renourishment</b> adjacent to Chester Rd car park using 100 m<sup>3</sup> sand from CYC. Annual or 2-yearly with dependent on wind patterns (or linked to other sand harvesting). <i>Cost: \$3.5k. Sand from CYC (2-yearly)</i></p> <p>Backfill between <b>revetment crest</b> and car park. Create a wider splash zone at the crest between the top of revetment and car park kerbing. <i>Cost for backfill with coarse gravel: \$2k pa + in-kind labour</i></p>
