## Appendix E Town of Claremont

### APPENDIX E.1 HISTORIC AERIAL IMAGE COMPARISONS FOR TOC

### APPENDIX E.3 STRUCTURE CONDITION AND FUNCTION COMPARISON TOC

## APPENDIX E.4 DAMARA WA (2015) STRUCTURE AND DRAIN ASSESSMENTS FOR TOC

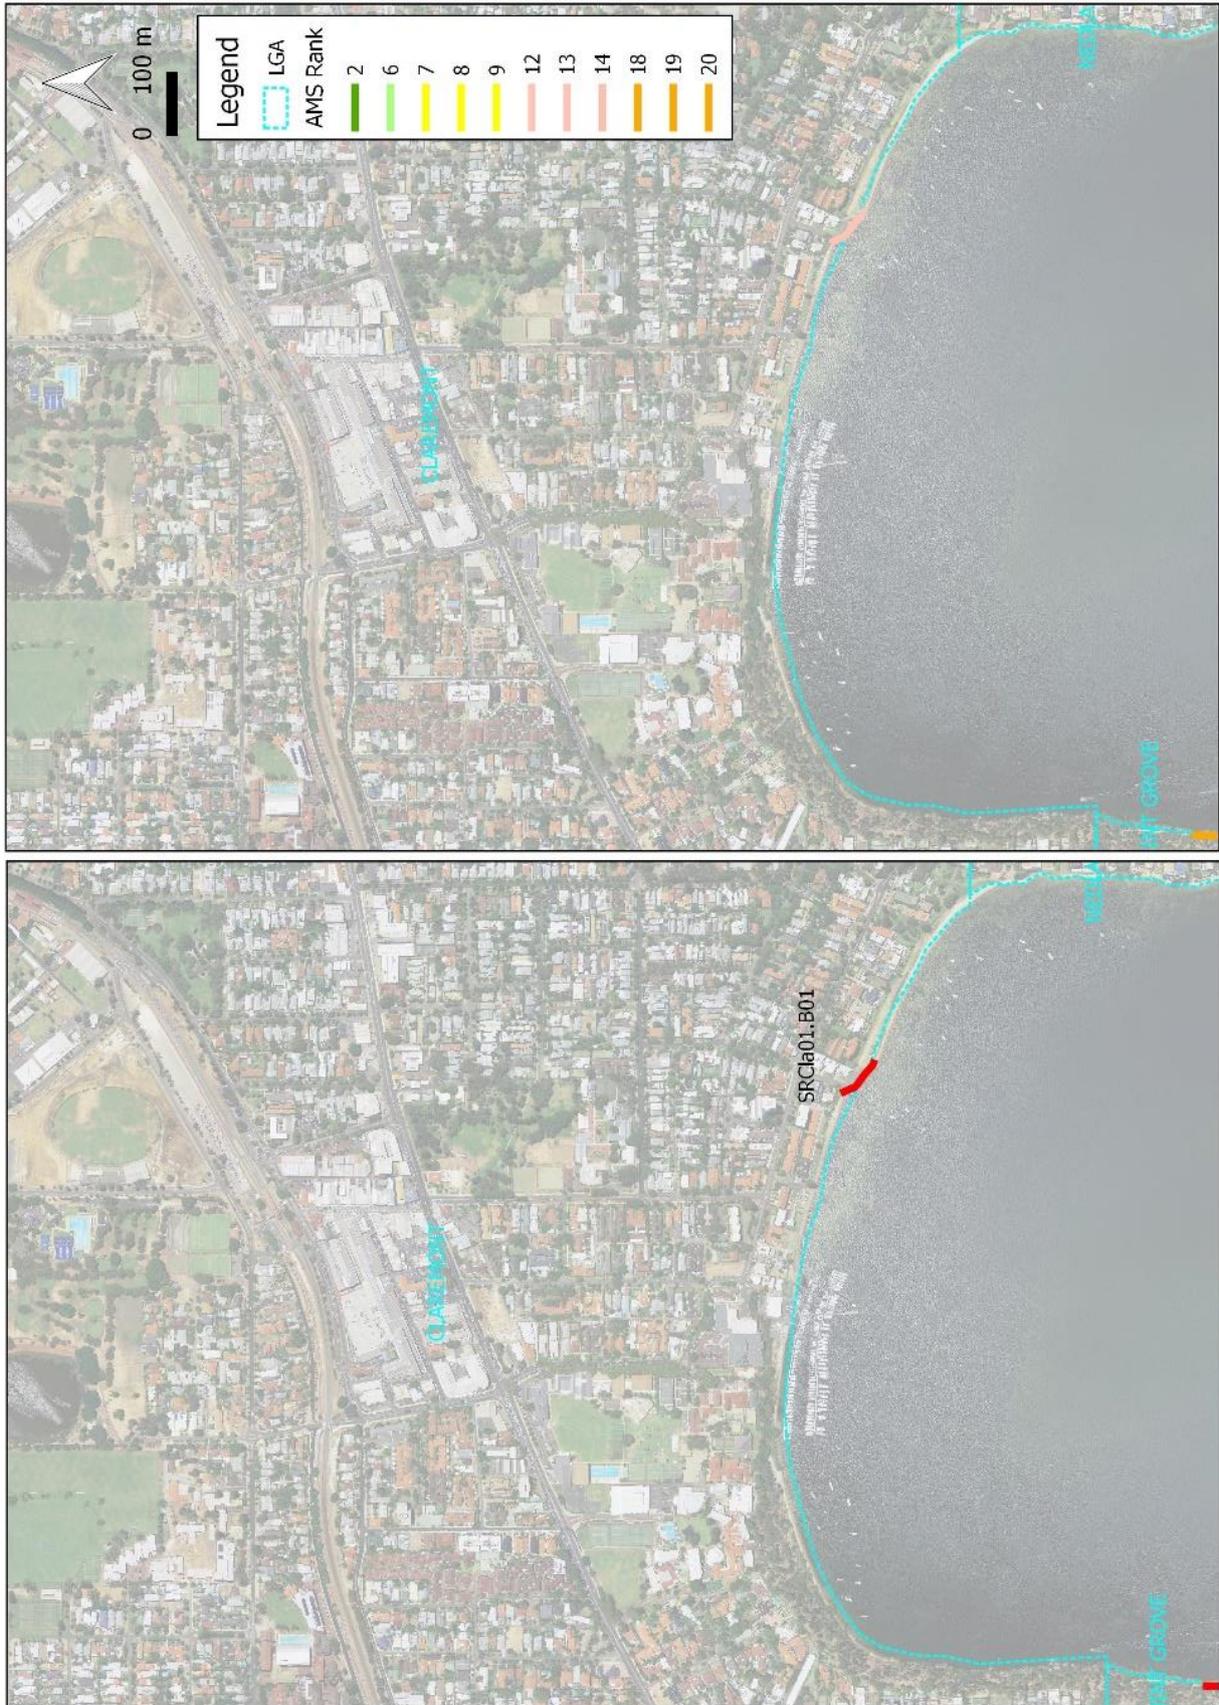
Figure 12-72: Town of Claremont AMS January 2015 Rank for Structures

The number of structures and drains (left panel), along with their AMS rank (right panel), are shown in Figure 12-72 and Figure 12-73. Further explanation of the condition, consequences and management requirements are provided in Table 12-36 and Table 12-37. Not all assets were assessed. For example, drains ending in code .D0x were not assessed.
